Manhole Inspection Summary

Manhole # S33MM1008MH

Insp Date: **2/27/07 1:54 PM**

Location Address: **18 CHARLCOTE PL**

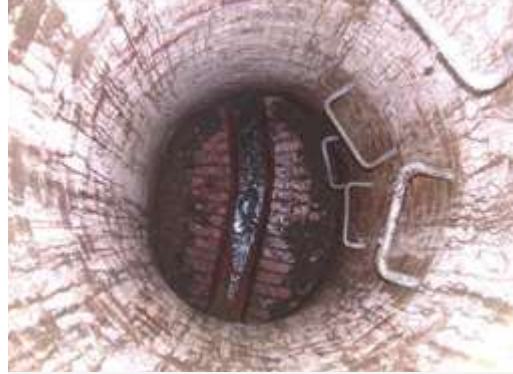
Top View

Evidence of surcharge - Bench debris.
Channel debris.

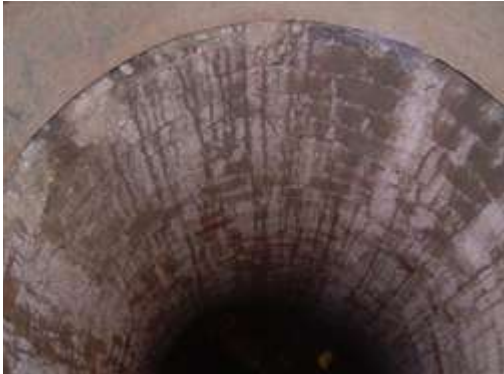
Defect

Frame leaks. Adjustment deterioration
and infiltration. Corbel and Barrel
infiltration - other side.

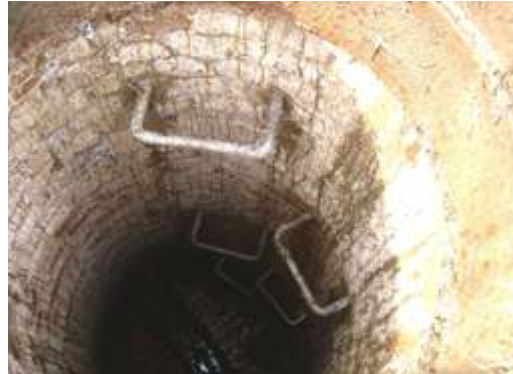
Defect

Frame leaks. Adjustment deterioration
and infiltration. Corbel and Barrel
infiltration.

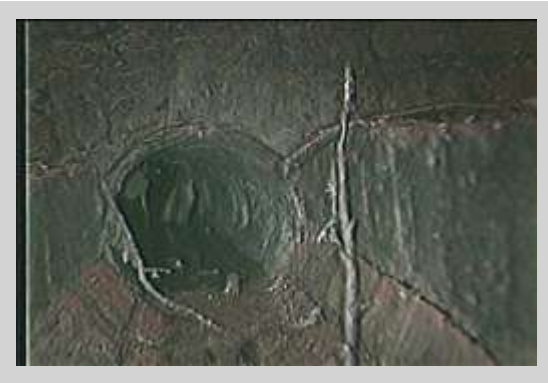
Pipe Out @ 12 O'Clock

Barrel deterioration and infiltration. Channel deterioration.

Deposits: ☐ None ☒ **Mud** ☐ Sludge ☒ **Debris** ☐ Grease

Infiltration: **None** Pipe Seal Cond: **Roots**

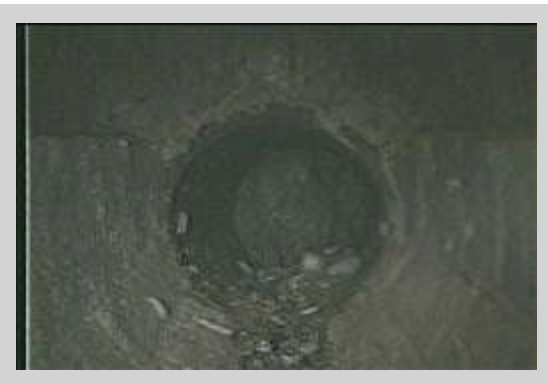
Pipe In @ 7 O'Clock

Plugged.

Infiltration: **Evidence** Pipe Seal Cond: **Unknown**
